**REPORT INTO A COLLISION
BETWEEN TWO
JET SKIS IN CASHLA BAY,
CO. GALWAY
ON 2nd OCTOBER 2006,
RESULTING IN SERIOUS INJURY
TO ONE INDIVIDUAL**

REPORT No. MCIB/131

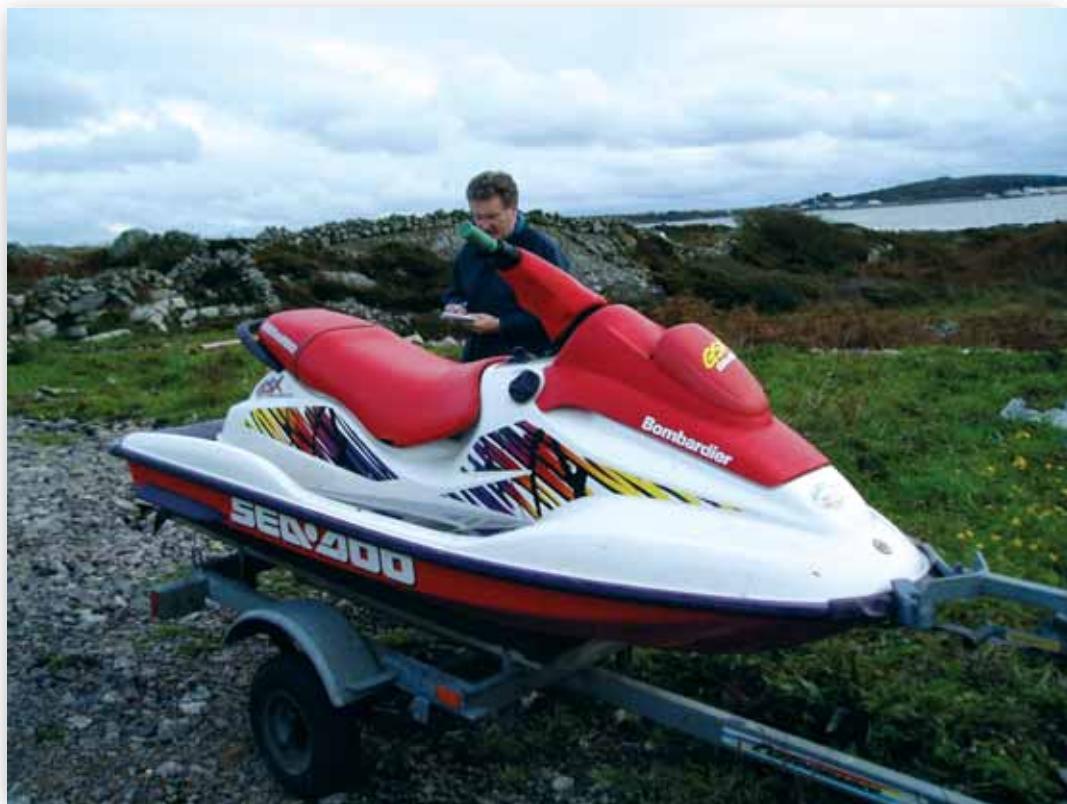
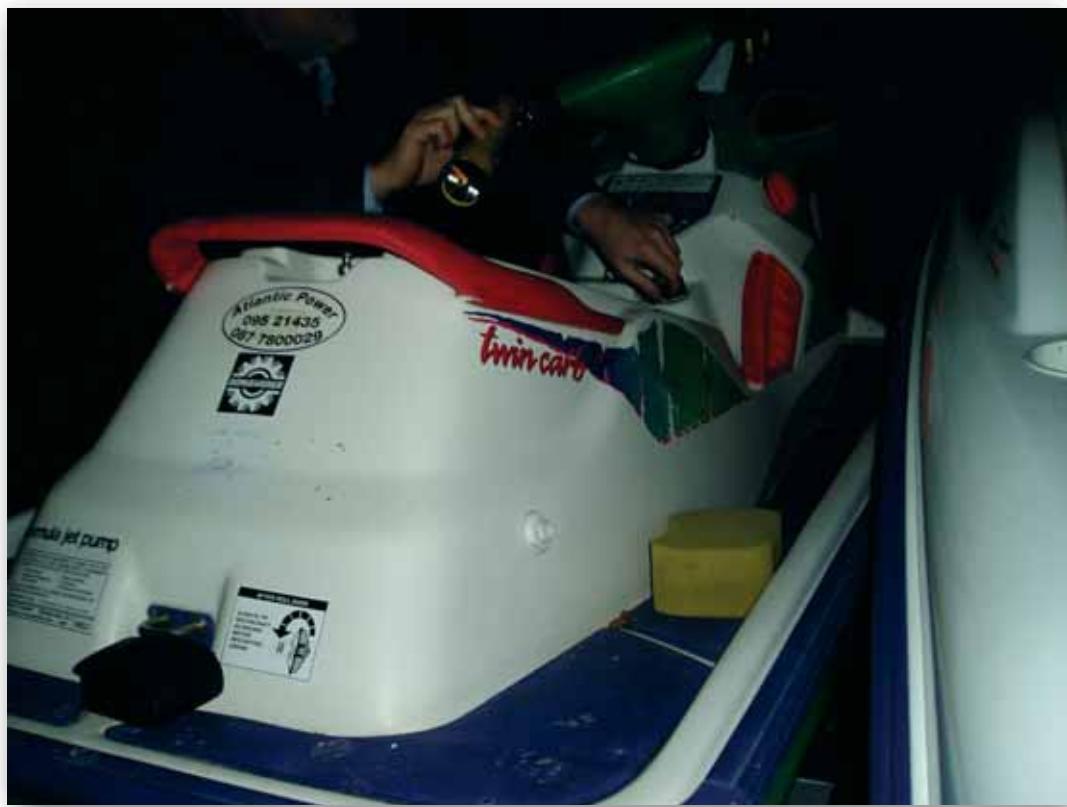
Appendix 8.1 Photographs of Jet Ski (A) and Jet Ski (B).

On inspection of both crafts, no indentation or structural damage was noted. The hulls were intact, with slight gel coat abrasion damage, which would not affect the stability or buoyancy of these crafts. In addition the rub rail/fender of Jet Ski (B) was damaged at point of contact. (See Appendix 8.1)

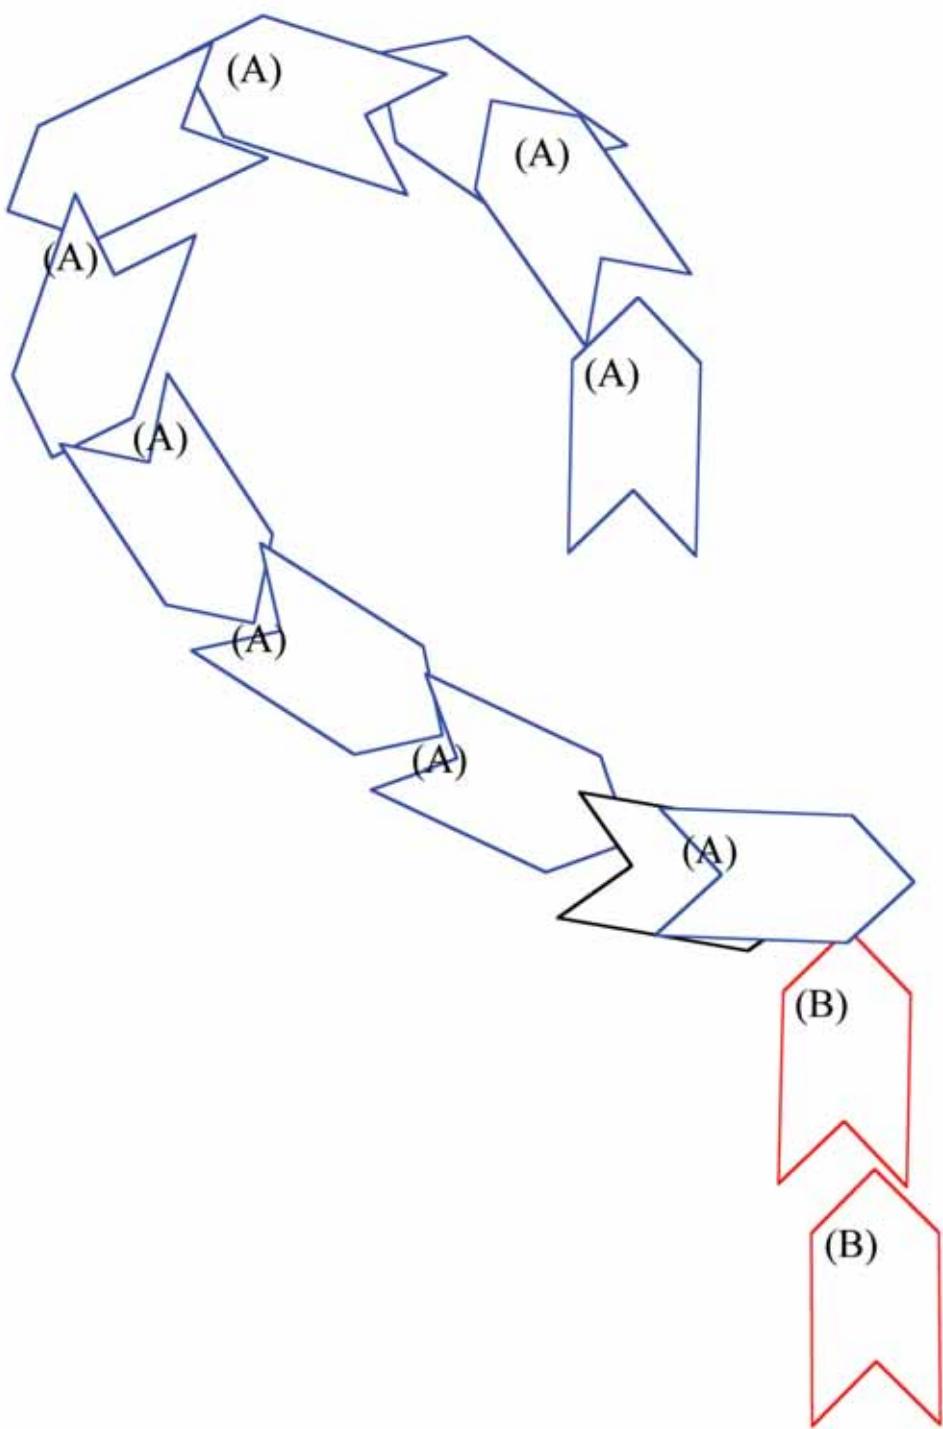
Appendix 8.3 Diagram showing how the Jet-Skis collided.

- 4.2 Whilst heading south, in the vicinity of Temple Point (As indicated on Chartlet (2) at Appendix 8.2), Mr. Folan, commenced a turn to his left describing an arc of approximately 260 degrees placing him in the direct path of Mr. Lydon. (As indicated at Appendix 8.3)

- 4.3 By their own admission it is accepted that by now both craft had accelerated to approximately 40 Knots. Immediately prior to impact both craft were in the wake of craft (A) which would have the same effect as a short, heavy swell. Craft (B) rose on the crest of the wave striking craft (A) and injuring the right side of Mr. Folan. On impact both men were thrown from their craft. The dead-man mechanism operated automatically thereby cutting the engines. Although Mr. Lydon was in a temporary state of shock he managed to remount his jet ski. Unfortunately Mr. Folan had sustained serious injury and had to be rescued.
