**REPORT INTO A COLLISION
BETWEEN TWO
JET SKIS IN CASHLA BAY,
CO. GALWAY
ON 2nd OCTOBER 2006,
RESULTING IN SERIOUS INJURY
TO ONE INDIVIDUAL**

REPORT No. MCIB/131

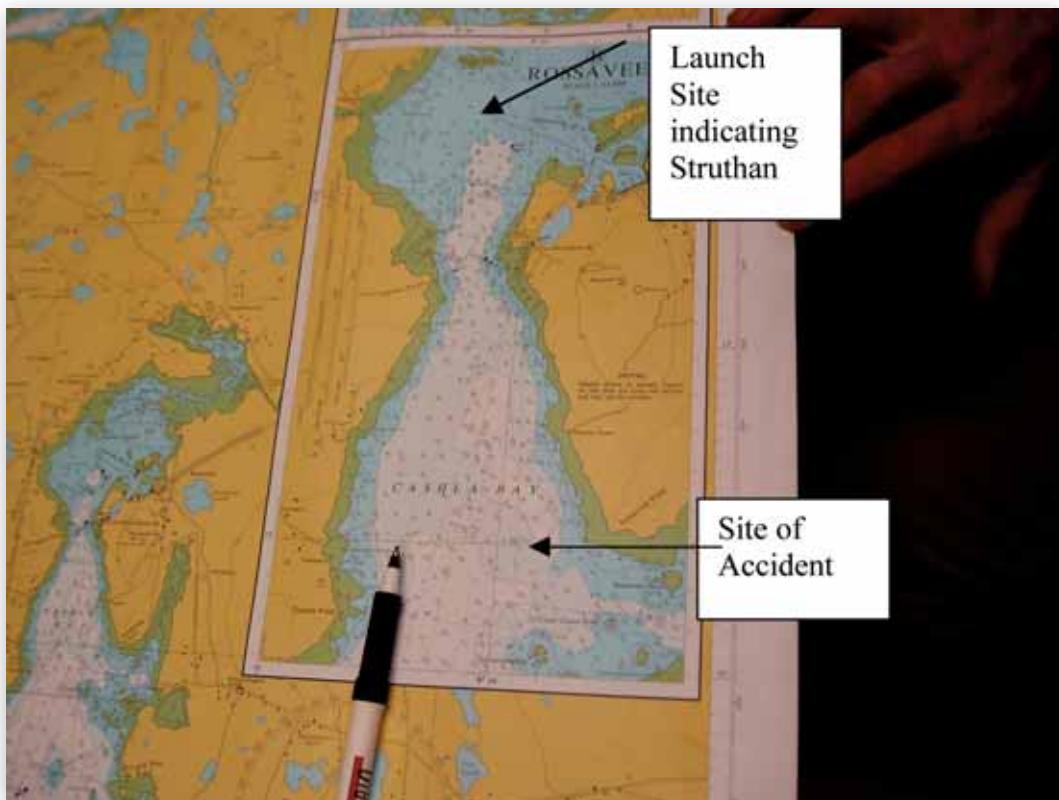
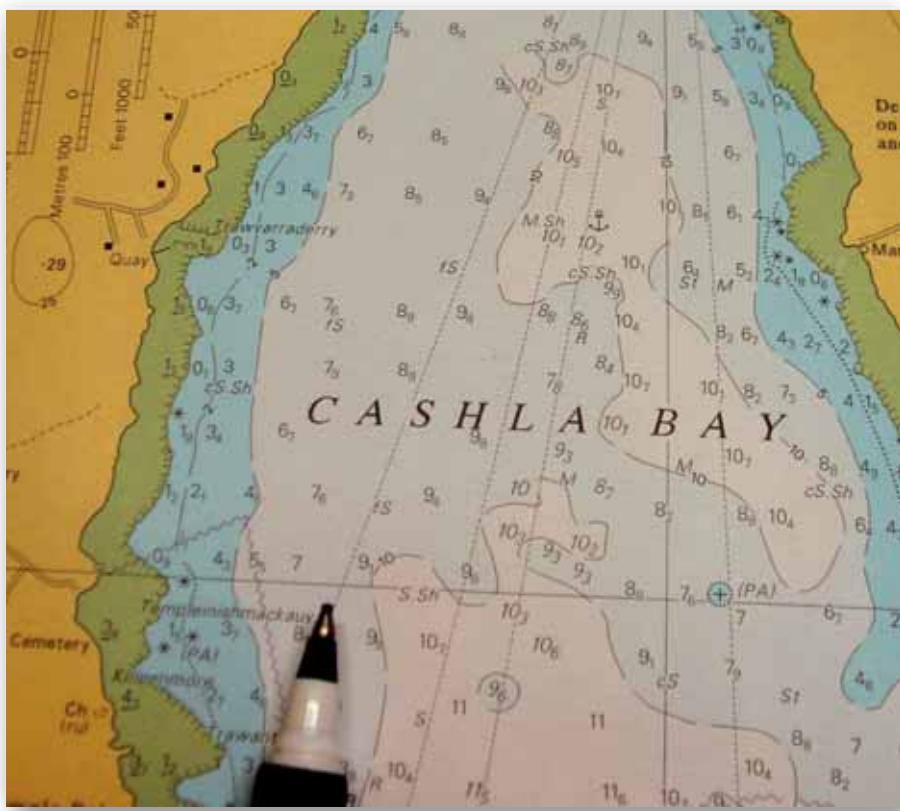
Appendix 8.2 Chartlets of the area.

- 5.1 Mr. Mullen, on satisfying himself that Mr. Lydon was not in danger, took Mr. Folan into his RIB. They proceeded to Struthan (See Appendix 8.2, Chartlet 1). Mr. Lydon followed on his own jet ski with Mr. Folan's jet ski in tow.
- 5.2 On arrival at Struthan Pier, Mr. Folan was transported by car to a nearby house where a doctor was summoned. Due to the nature of his injuries, the doctor requested an ambulance and Mr. Folan was brought to University College Hospital Galway where he was treated for three broken ribs, a punctured lung and a broken fibula of right leg compounded by deep lacerations.
Mr. Folan spent two weeks in hospital as a result of the injuries sustained in this incident.
